Report No.	NVH-20260607-D86BFB
Issued	2026-06-10
Status	Emailed

# Vehicle History Report

<b>Chassis number</b>	RU1-1220844
<b>Manufacture date</b>	2017-03-21
<b>Make</b>	HONDA
<b>Model</b>	VEZEL
<b>Body</b>	DBA-RU1
<b>Grade</b>	RS HONDA SENSING
<b>Engine</b>	L15B
<b>Drive</b>	2WD
<b>Transmission</b>	AT

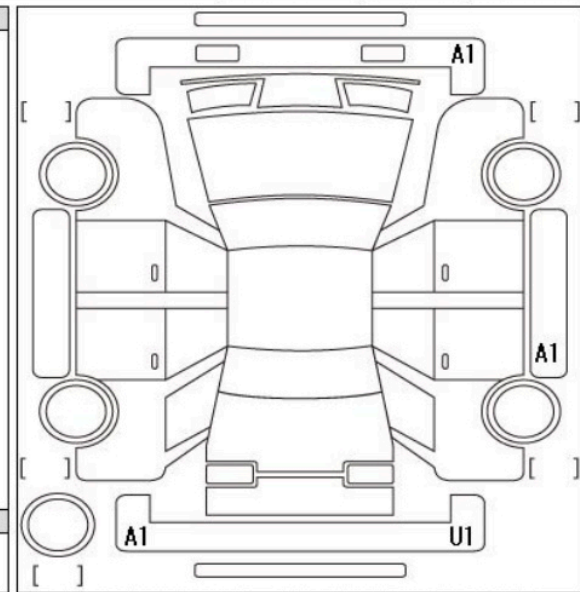
検査員記入欄
サイドミラーA
事務局よりご案内
キーケース (部品)

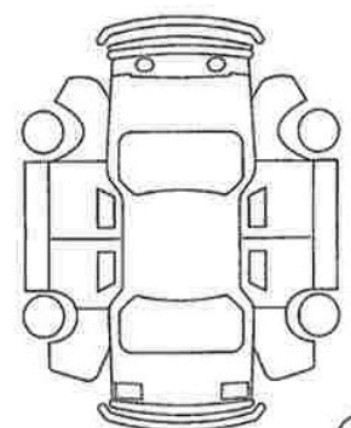
# MIRIVE 出品票

[1010]		初度登録		車名		ドア		グレード		駆動		評価点	
75165		29 3		ヴェゼル		5		RS・ホンダセンシング		2WD 4WD		1	
西暦		年		型式		排気量		保証有		定員			
2017				DBA - RU1		1,500		有・無		5			
走行		車検		色 (Col.No)		燃料		外装		内装			
42000		km		パール		◎・D・電気							
シフト		エアコン		リサイクル精託金		純正装備品		ナビ		DTV			
AT		AAC		12,850		PS PW AW エア ABS 革 SR		ナビ		DTV			
<遠航事項>				名義期限		<セールスポイント>							
冠水歴あり				月 日

輸入車									
				ディーラー・銀行									
				左H・右H									
<検査員記入欄>													
Fガラス (キズ・霰石・ヒビ・リペア跡・X要)													
内装 (キズ・スレ・汚れ・シミ・コゲ・穴・キレ・破れ)													
オーディオ (無し・穴) / タイヤ (スタッドレス)													
冠水歴アリ													
				★ Car Wash ★		★ Car Wash ★							
				内装 B 施行済		外装 B 施行済							
後送品		ナビ取付		ロム/BD		B-CAS		リモコン		登録番号		車台番号	
ナンバー		スベアキー		キーレス		スマートキー				1220844

ホイールCPキズ・ワレ/ドアミラーキズ・ワレ  
小キズ有・小リ有・補修有
