Report No.	NVH-20260607-D86BFB
Issued	2026-06-10
Status	Emailed

# Vehicle History Report

<b>Chassis number</b>	RU1-1220844
<b>Manufacture date</b>	2017-03-21
<b>Make</b>	HONDA
<b>Model</b>	VEZEL
<b>Body</b>	DBA-RU1
<b>Grade</b>	RS HONDA SENSING
<b>Engine</b>	L15B
<b>Drive</b>	2WD
<b>Transmission</b>	AT

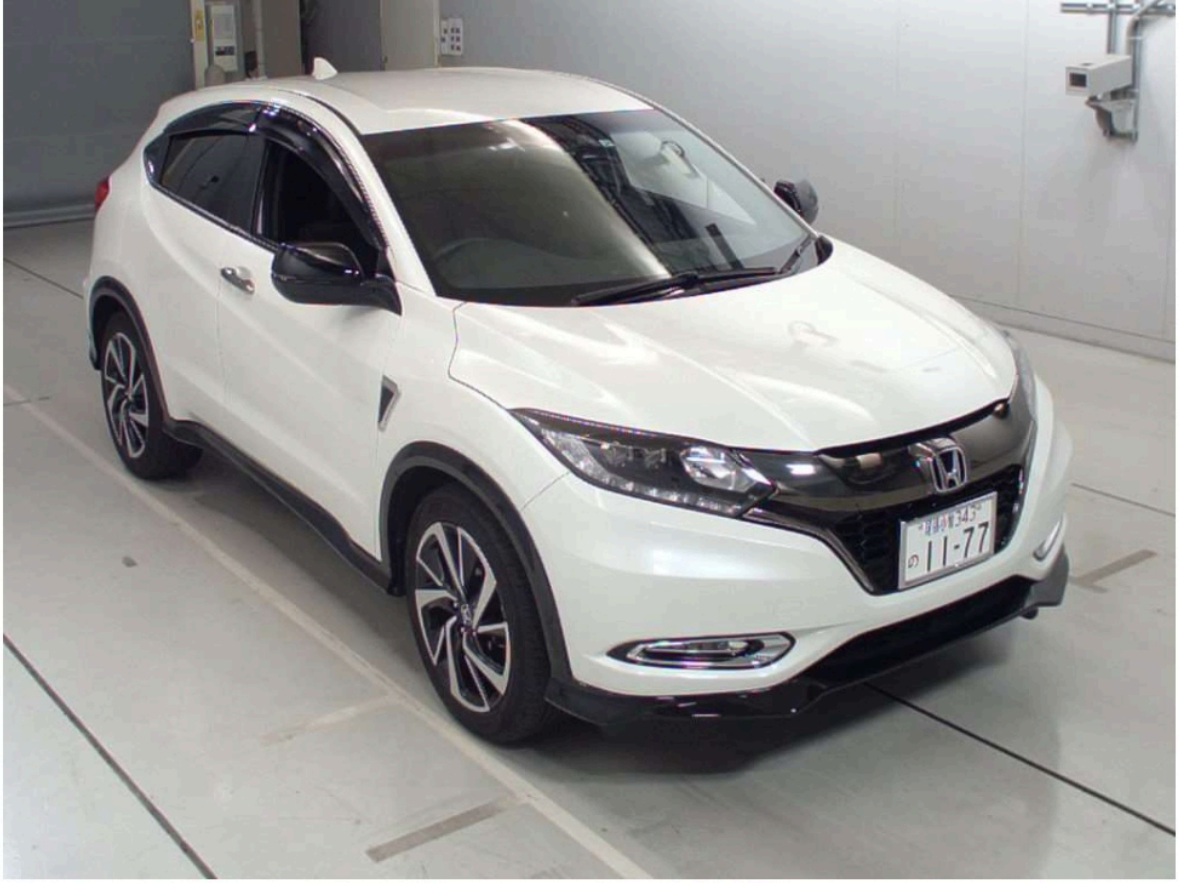
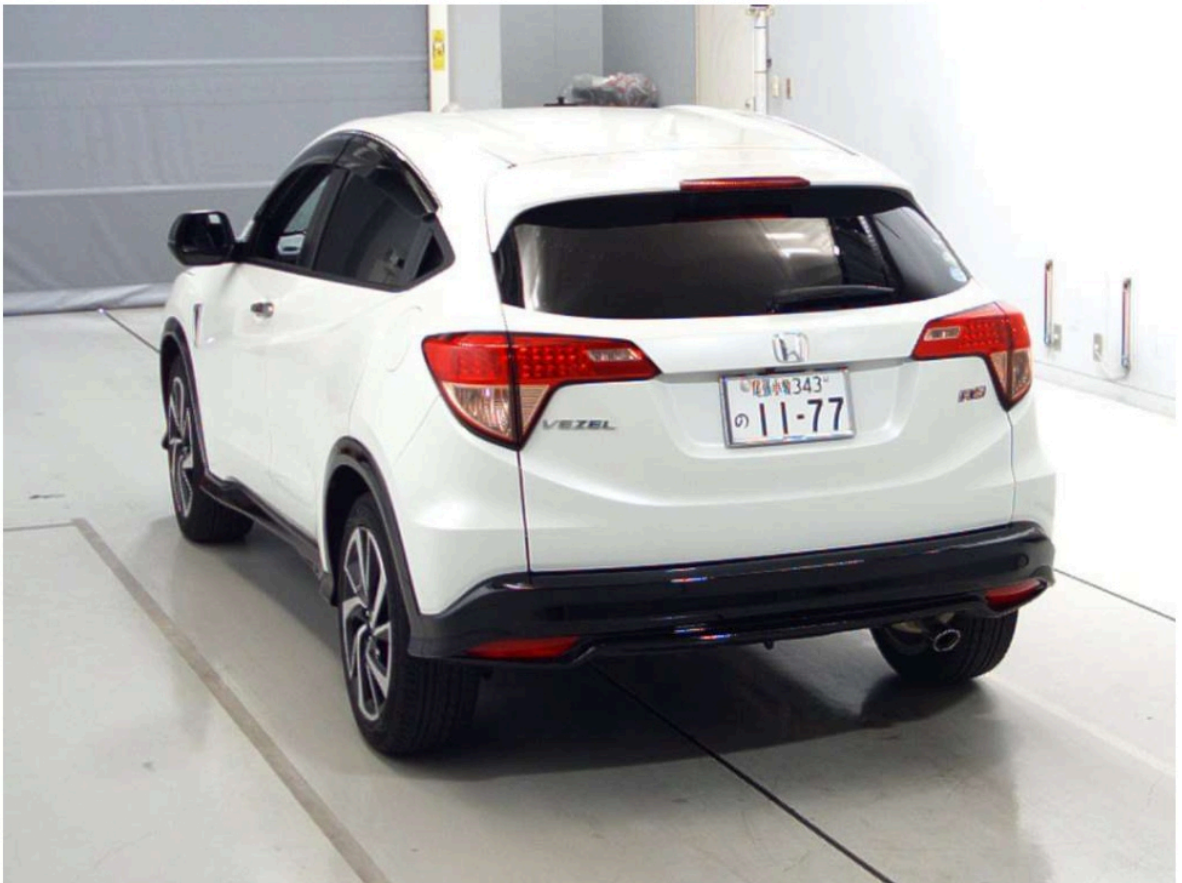
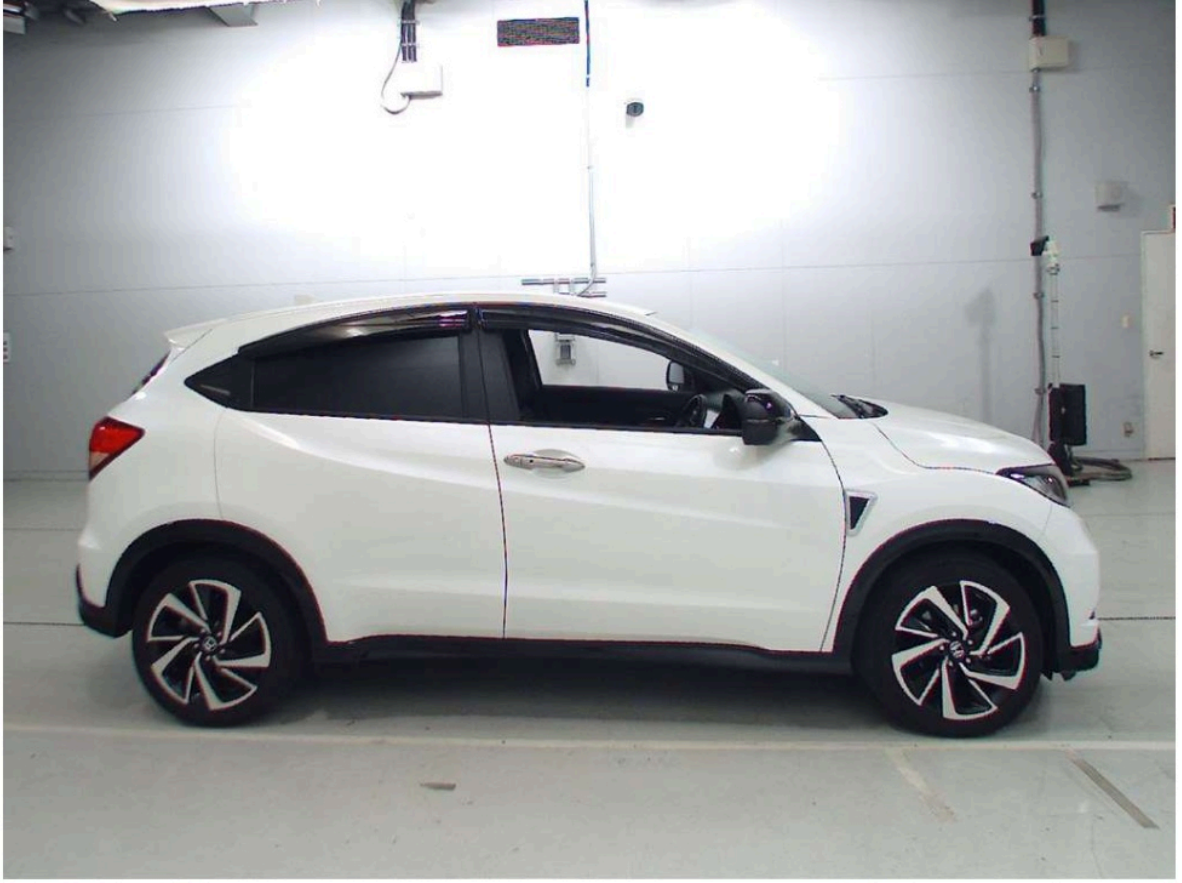
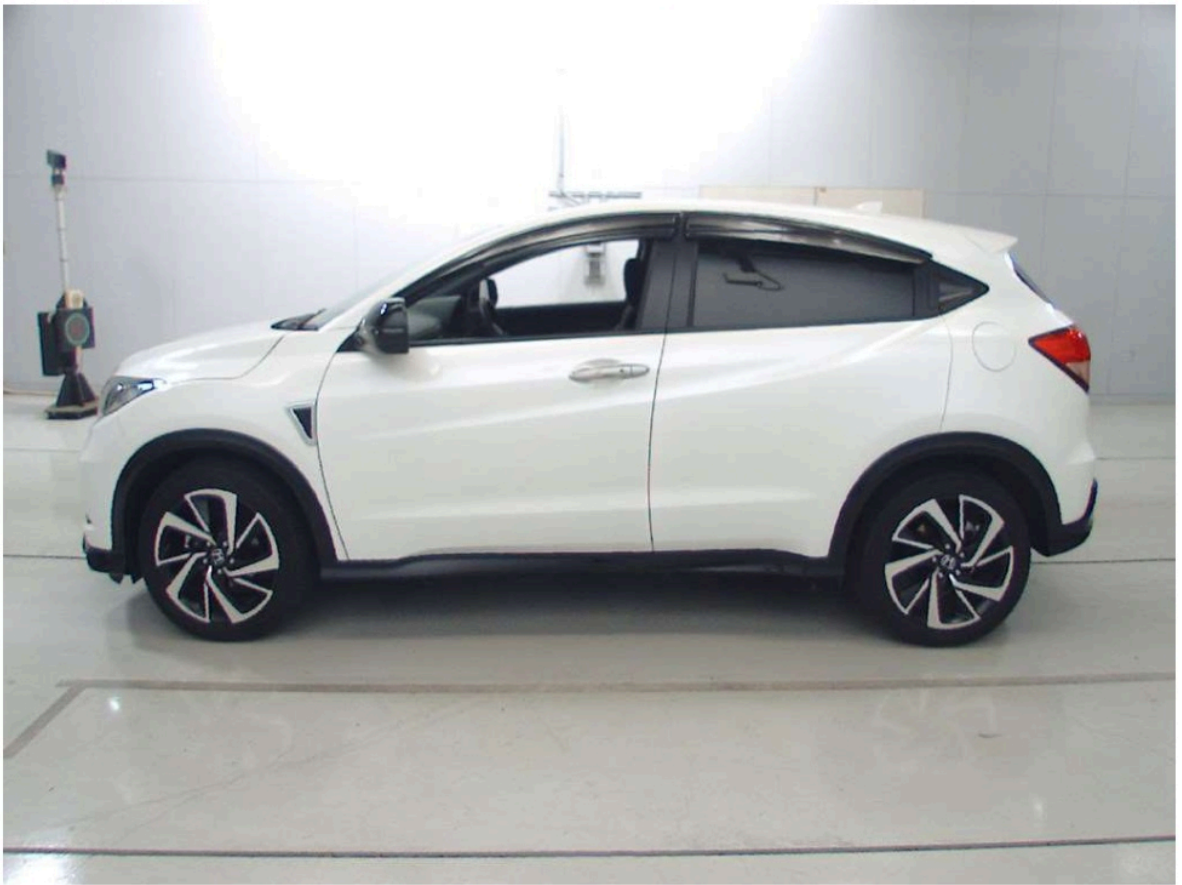
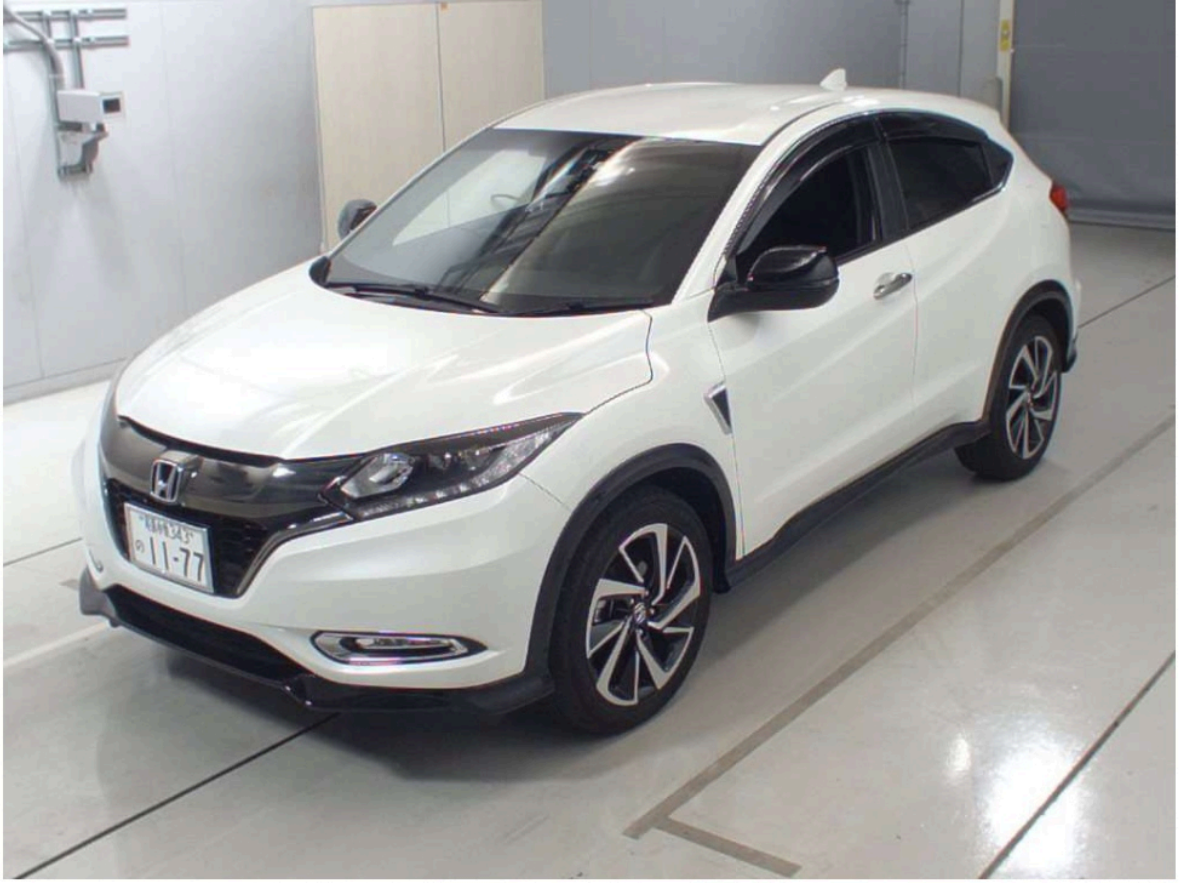
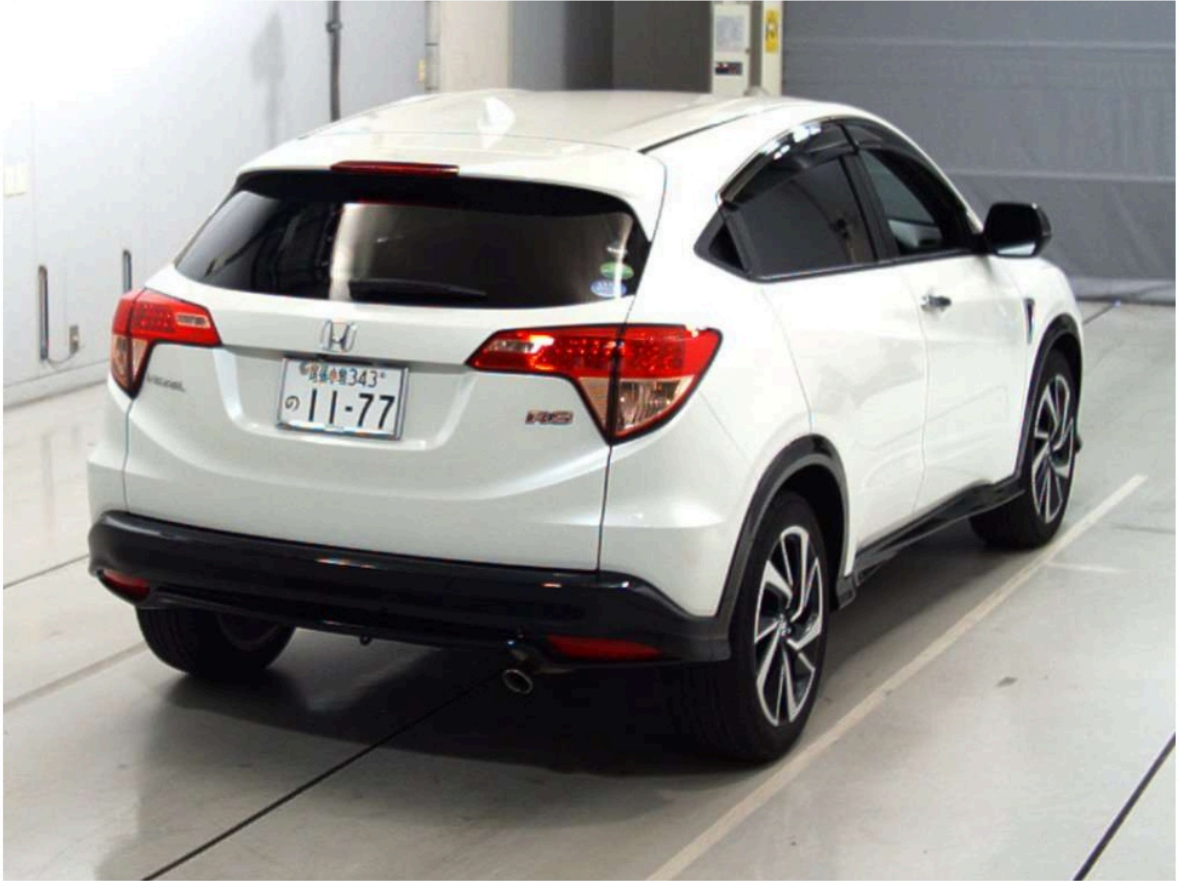
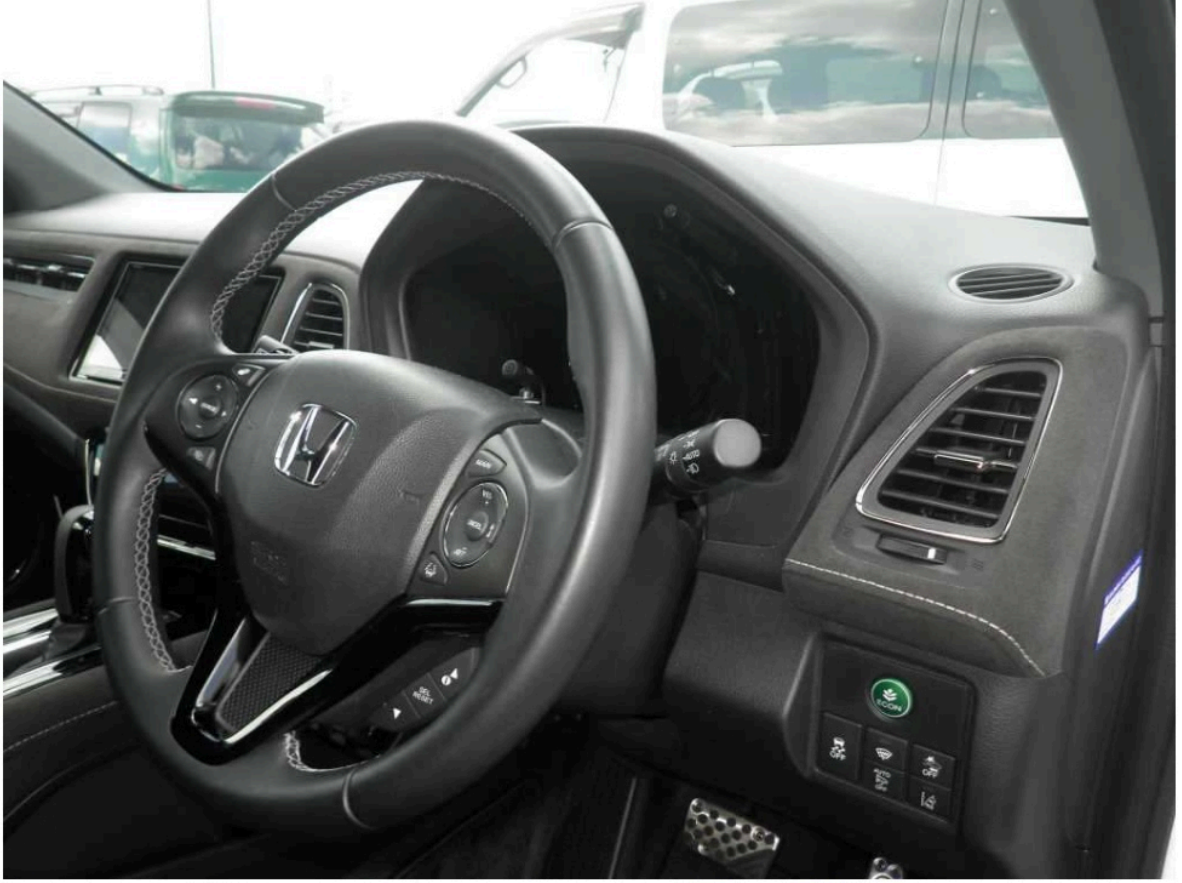
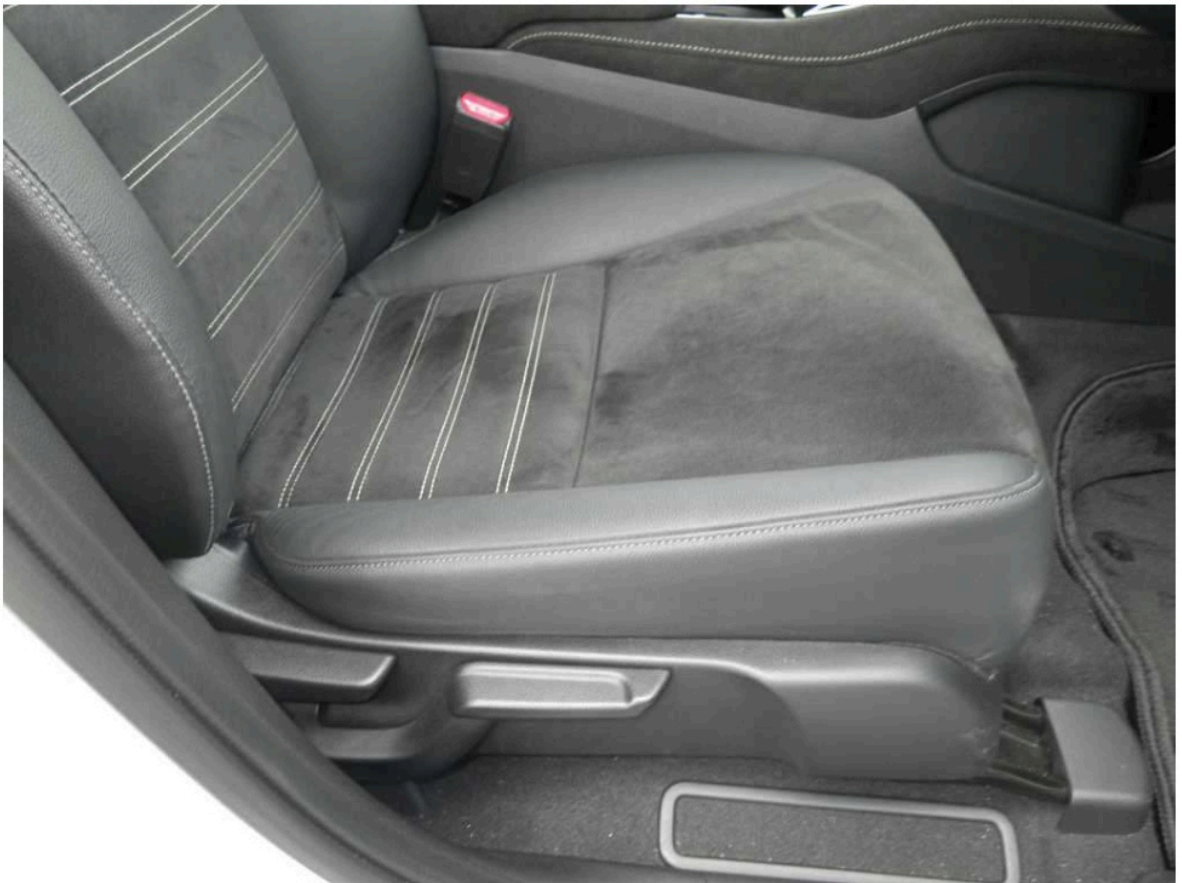
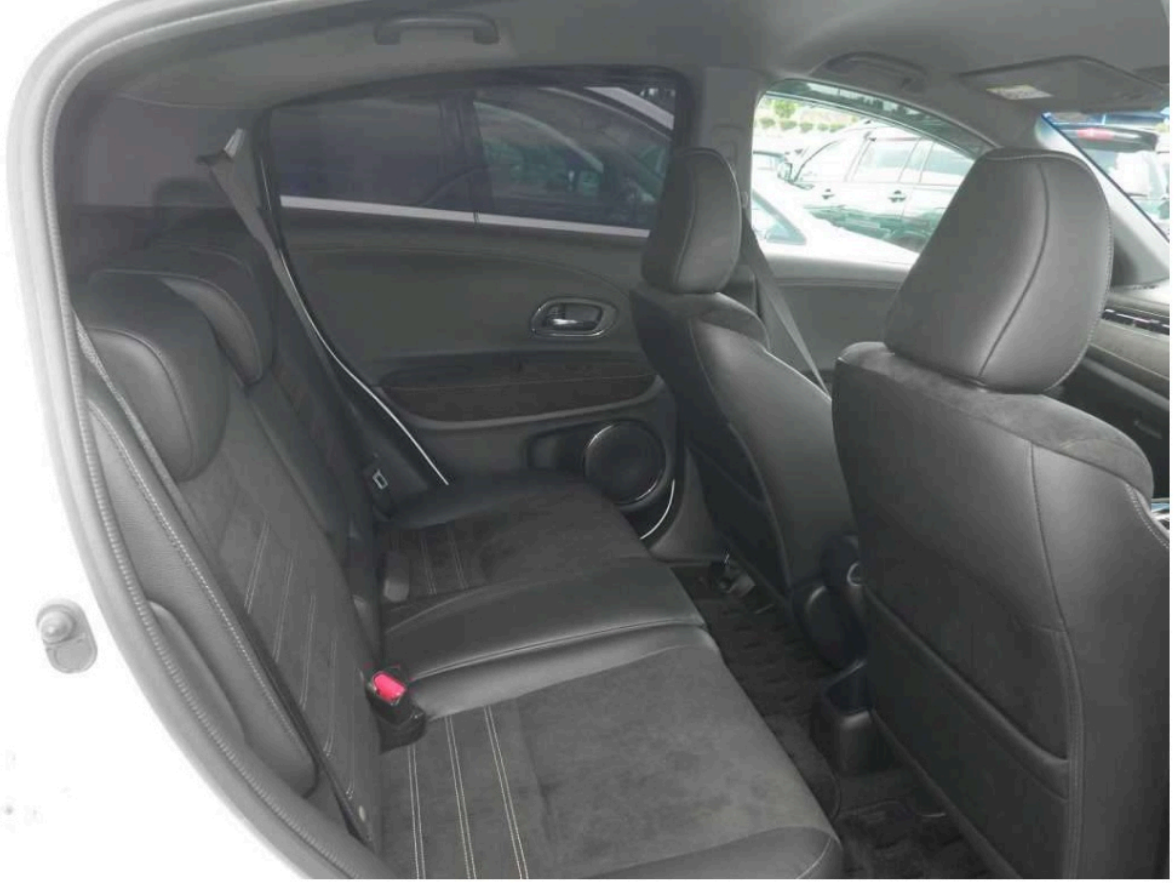
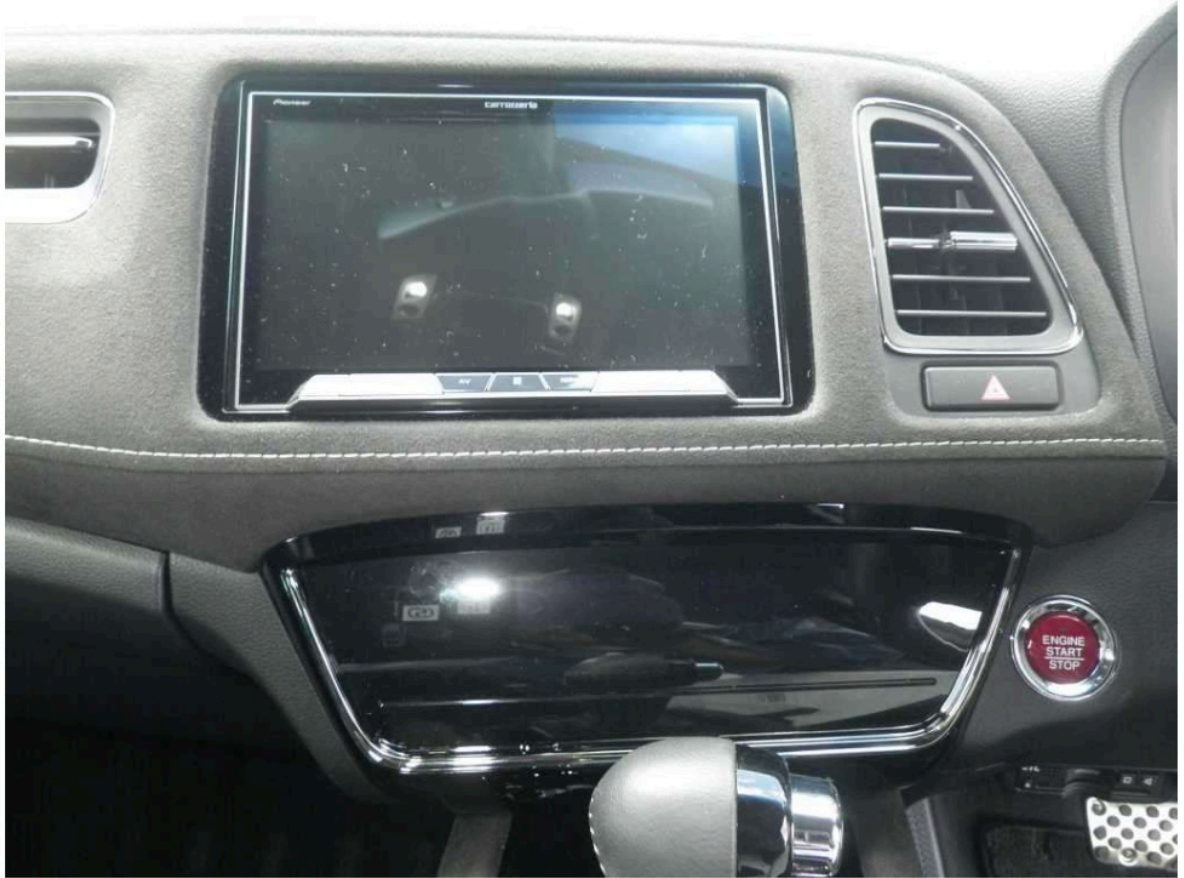
**Important Customer Attention:** The later MIRIVE Saitama auction record shows auction grade 1, and the auction sheet includes a water/flood history note. Because water/flood history can affect electrical systems, interior components, sensors, wiring, engine-related parts and long-term reliability, this point should be checked very carefully before any final decision. Even if accident/repair, rollback, recall and contamination items are shown as no problem in the history summary, the auction sheet warning must be treated as an important condition note.

Problem type	Reported	Date reported	Data source	Details / Airbag
Collision	✓ Not reported			
Malfunction	✓ Not reported			
Theft	✓ Not reported			
Fire damage	✓ Not reported			
Water damage	✗ Reported			Flood / water-damage indication found. Check auction sheet carefully.
Hail damage	✓ Not reported

For this reason, Nippon Vehicles strongly recommends reviewing both auction sheets, all photos, interior condition, underbody condition, engine room, electrical functions, warning lights, odor/moisture signs, rust/corrosion points, and any available inspection or video evidence before purchase/export. This report should be used as one important reference together with physical inspection, customer requirements and final export documents. Final purchase/export decision should be made only after carefully understanding the vehicle's history and present condition.

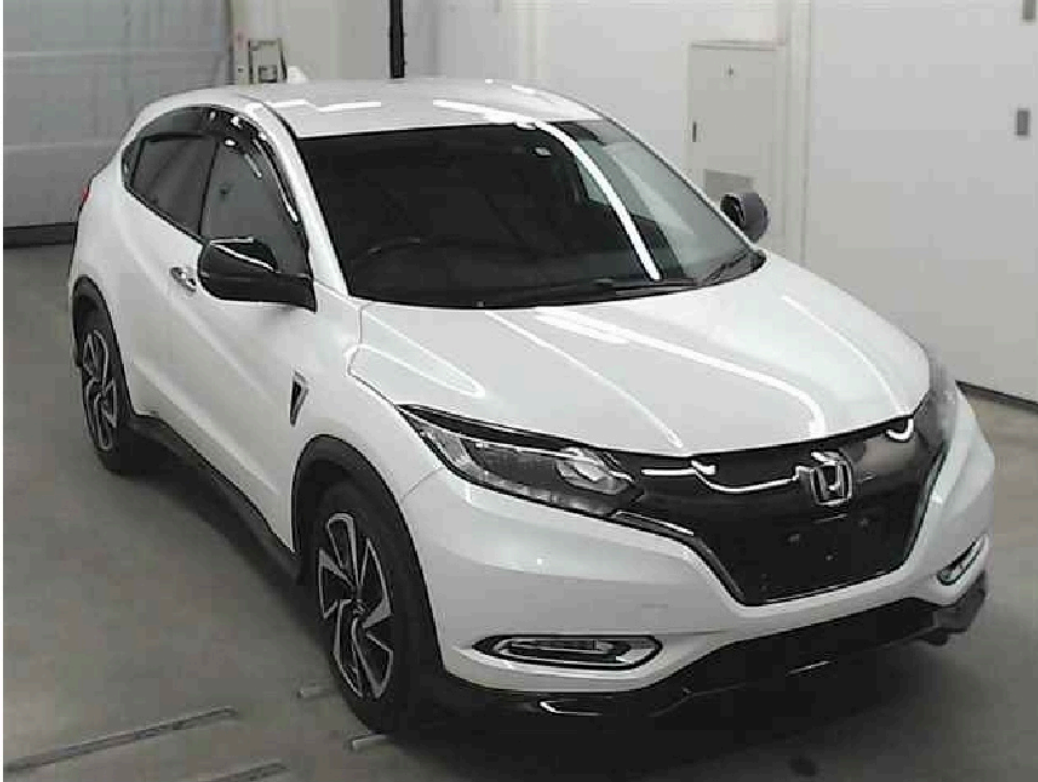
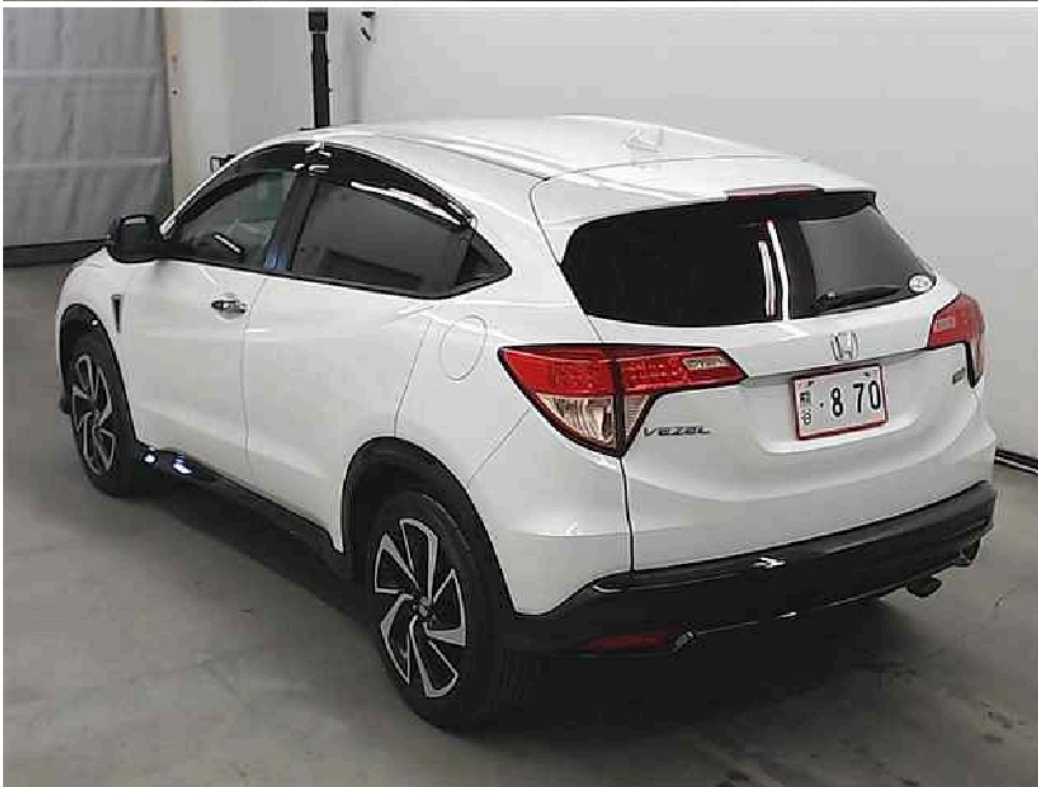
# MIRIVE 出品票

輸入車									
				ディーラー・銀行									
				左H・右H									
<検査員記入欄>													
Fガラス (キズ・霰石・ヒビ・リペア跡・X要)													
内装 (キズ・スレ・汚れ・シミ・コゲ・穴・キレ・破れ)													
オーディオ (無し・穴) / タイヤ (スタッドレス)													
冠水歴アリ													
				★ Car Wash ★		★ Car Wash ★							
				内装 B 施行済		外装 B 施行済							
後送品		ナビ取付		ロム/BD		B-CAS		リモコン		登録番号		車台番号	
ナンバー		スベアキー		キーレス		スマートキー				1220844

ホイールCPキズ・ワレ/ドアミラーキズ・ワレ  
小キズ有・小リ有・補修有
